Arbeitsbericht NAB 21-20

**TBO Marthalen-1-1:
Data Report**

**Dossier I
Drilling**

**National Cooperative
for the Disposal of
Radioactive Waste**

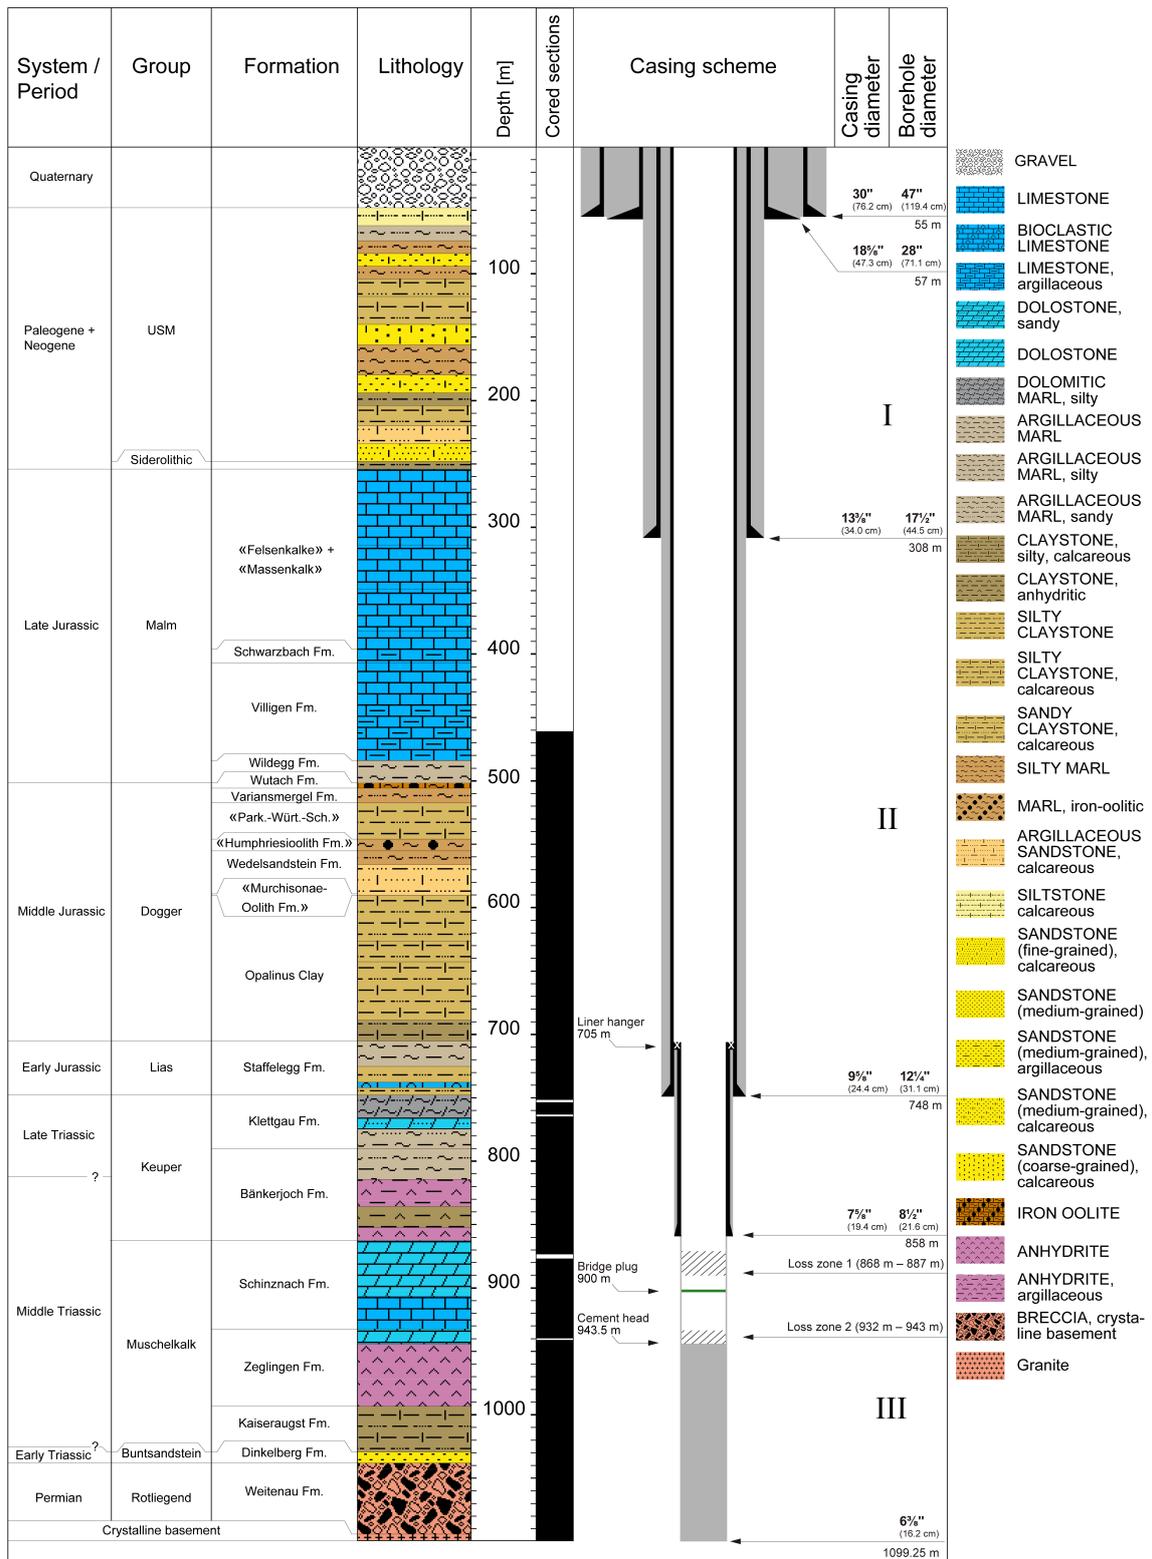
Fig. 1-3: Lithostratigraphic profile and casing scheme for the MAR1-1 borehole⁴

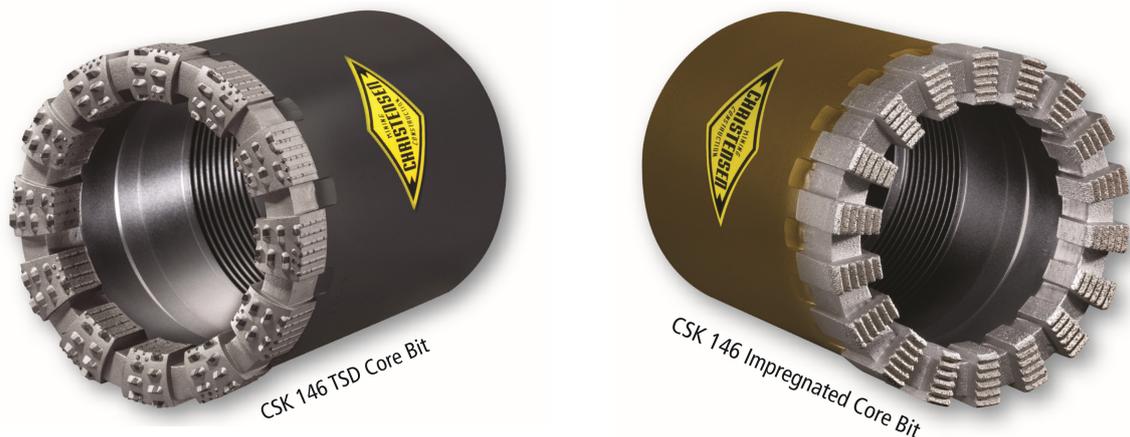
This type of core bit is designed for medium hard to extremely hard formations, but also for less to very abrasive rocks. Multiple layers of synthetic diamond fragments are sintered into a hard metal matrix. This compound behaves self-sharpening during progressive abrasion. Worn diamonds are released and replaced by new ones, until the matrix compound is completely eroded. This core bit is available with different types of matrix.

For MAR1-1, impregnated core bits with a medium to soft matrix were chosen mainly for coring limestone, dolostone, anhydrite and sandstone. This type of matrix is designed for less abrasive but hard, fine-grained and homogeneous formations.

Fig. 2-1: Synset core bit (left) and impregnated core bit (right)

Four new impregnated and four new synset core bits were used for coring the borehole. Used core bits were usually run in hole to execute roundtrips and condition the mud. A bit summary including bit grading for MAR1-1 can be found in Appendix K. All bit grading given in this report refers to the IADC dull grading system.

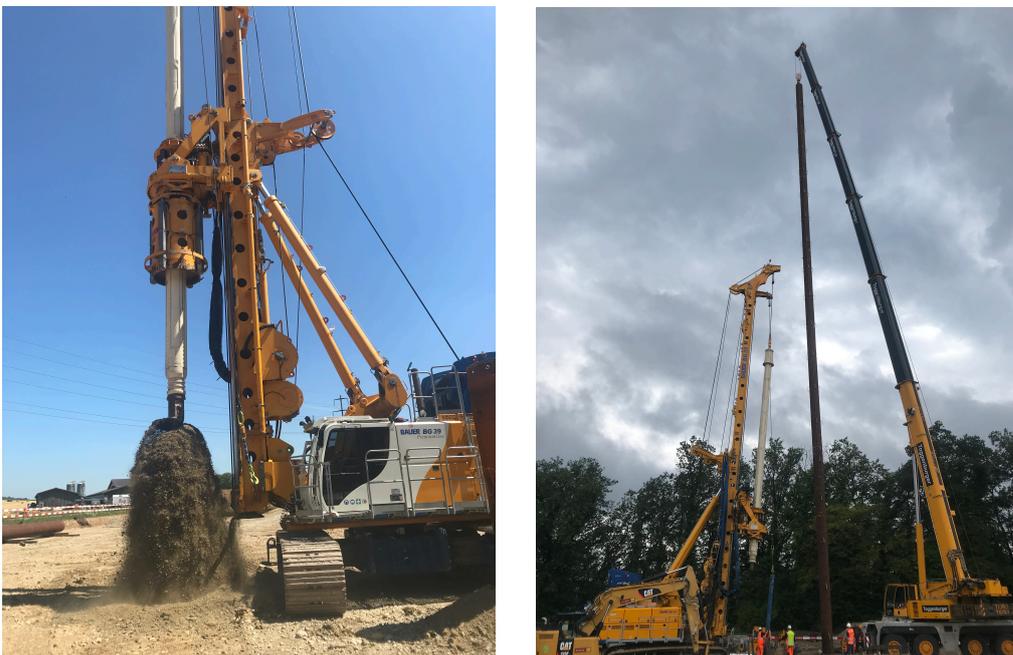
Because of the good ground conditions, it was not necessary to build a separate foundation for the conductor drilling rig. Conductor drilling operations were carried out on the very stable and pebbly ground (see Fig. 3-1). A 1'194 mm diameter hole was drilled dry through 48.5 m of Quaternary sediments and an additional 6.5 m of solid formations of the Untere Süsswasser-molasse. The 30" (762 mm) conductor pipe was welded and equipped with centralisers on the surface and then installed in one piece down to a depth of 55 m MD (see Fig. 3-1). The conductor was adjusted for verticality with several spirit levels while the cementation was performed through the annulus between the formation and the steel pipe. Logging showed a vertical deviation below 0.3° and homogeneous cementation to all sides.

Fig. 3-1: Drilling (left) and installation (right) of the conductor

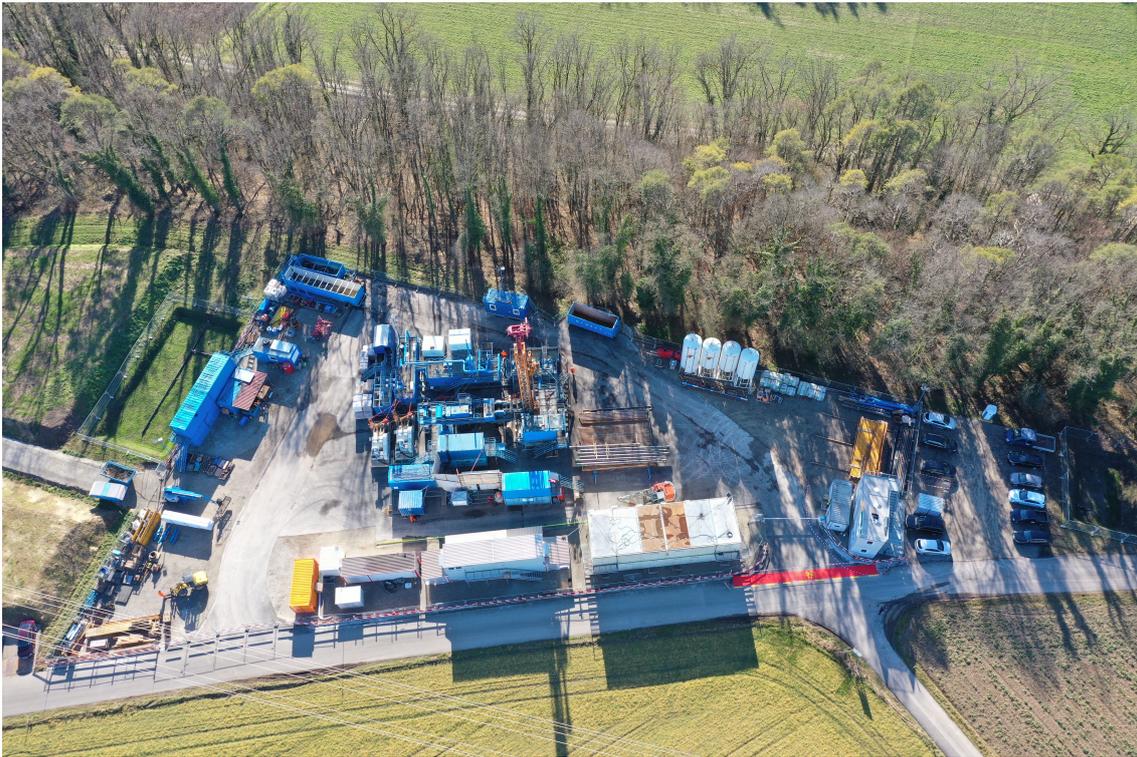
A construction plan, including plant management and arrangement of the drilling rig and its peripheral facilities, can be found in Appendix E. Fig. 3-2 shows the fully assembled drill site directly after construction.

Fig. 3-2: Drill site after installation of the drilling rig and peripheral facilities

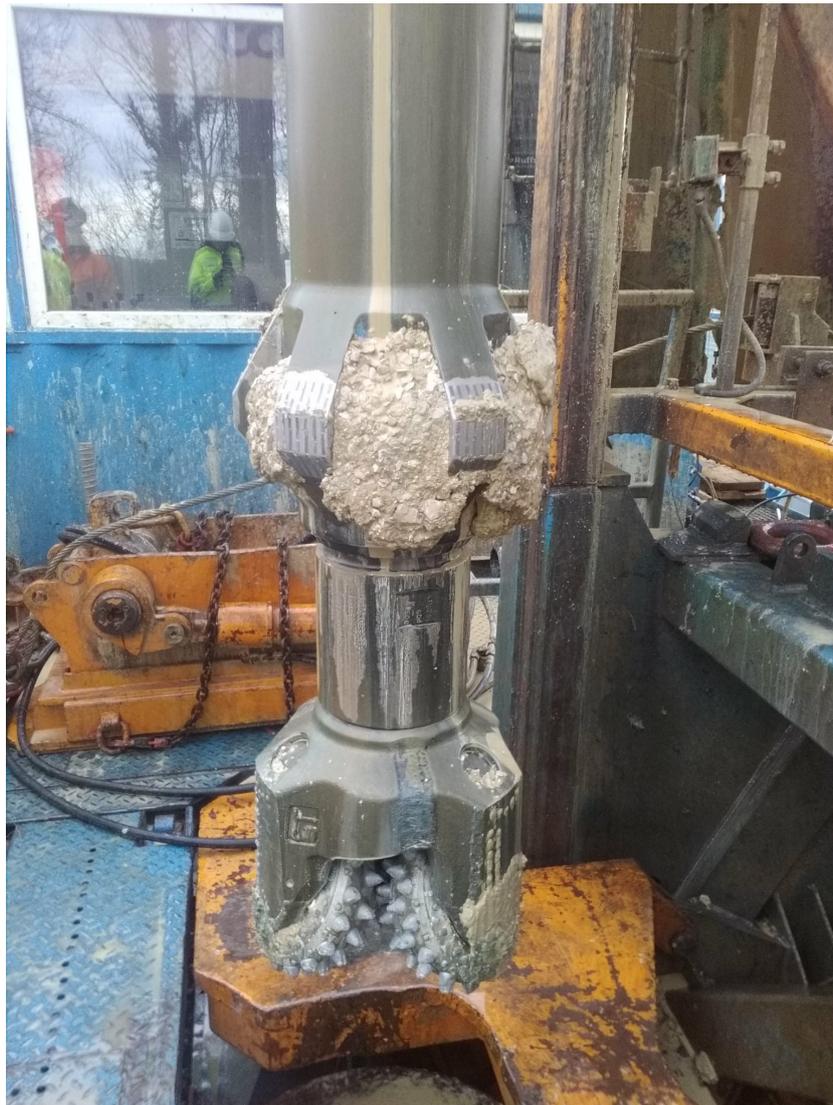
Section I was drilled destructively with a 17¹/₂" (444.5 mm) tricone bit and a 9⁵/₈" mud motor (see Fig. 3-3). BHA #3 used for this section can be found in Appendix N. Cement was first drilled from 46 m to 57 m MD. Afterwards, the Untere Süßwassermolasse was drilled until 256 m MD and finally the upper part of the Malm until 309 m MD. Single shot measurements were taken every 50 m to check the verticality of the borehole. All measurements were below 1° inclination.

Fig. 3-3: 17½" tricone bit and 9⅝" mud motor after POOH

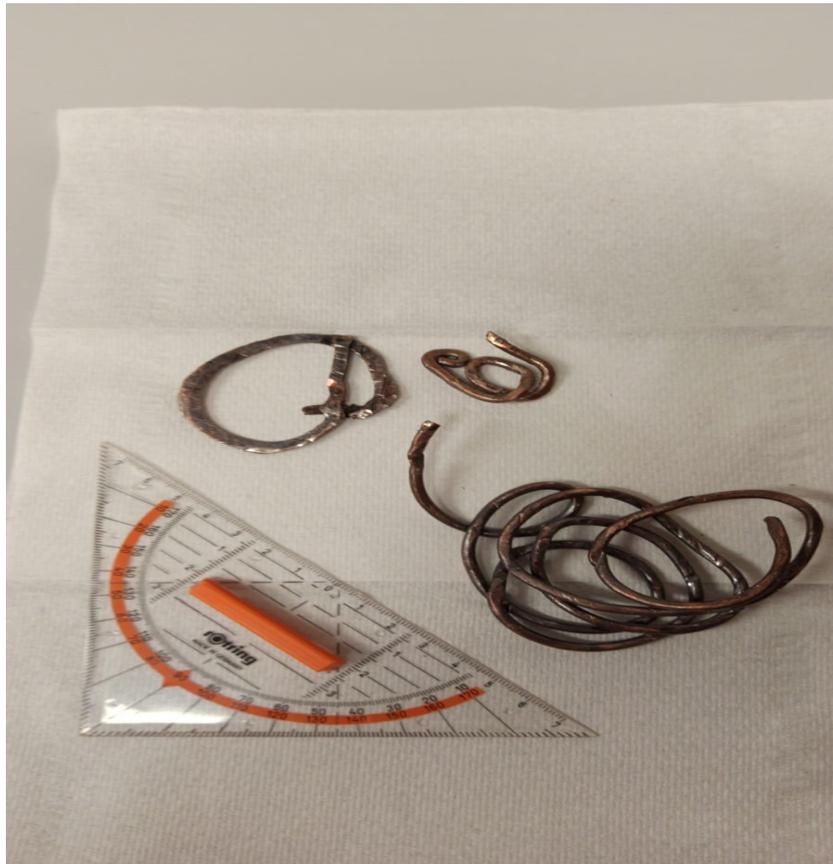
Fig. 3-5: Junk in hole recovered from 463 m MD

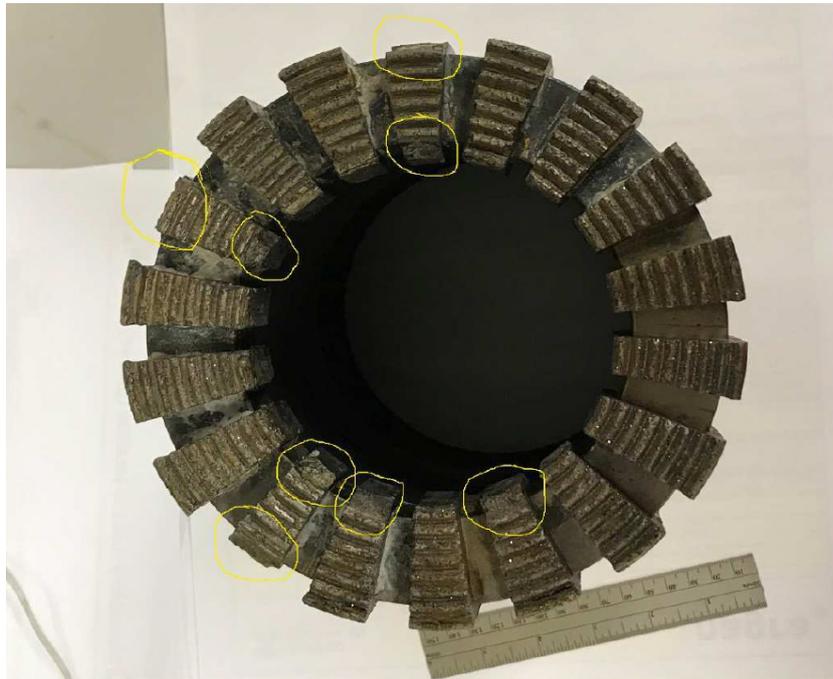
Fig. 3-6: Impregnated core bit after POOH from a depth of 503 m MD

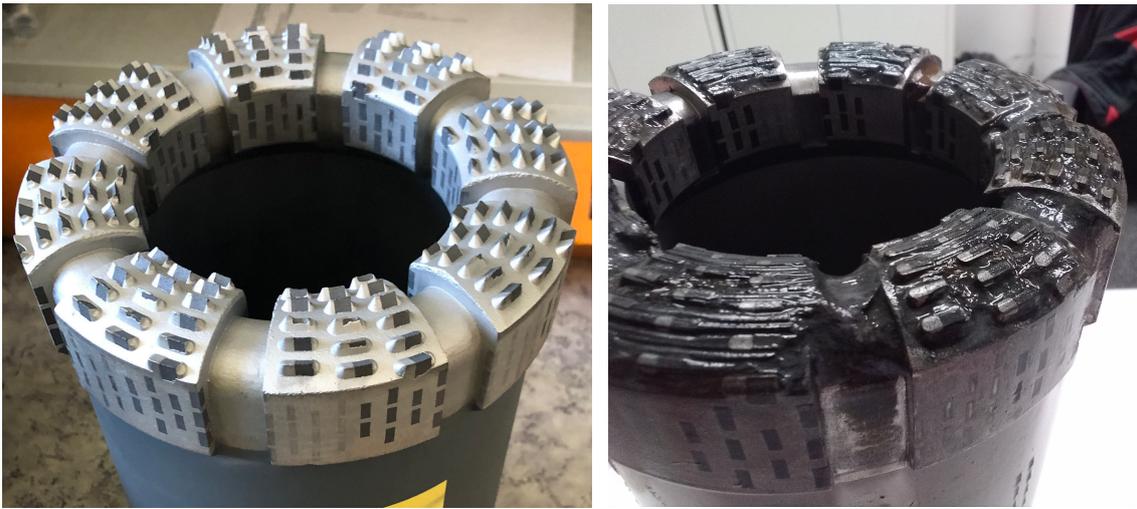
Coring operations continued to a depth of 655 m MD, including an additional bit trip as ROP was dropping constantly towards the end. The synset showed normal wear after POOH (see Fig. 3-7), which led to the decision to run another new synset core bit (see BHA #11 in Appendix N). This bit then cored until section TD at 750 m MD.

Fig. 3-7: Synset core bit before RIH (left) and after POOH (right) from a depth of 655 m MD

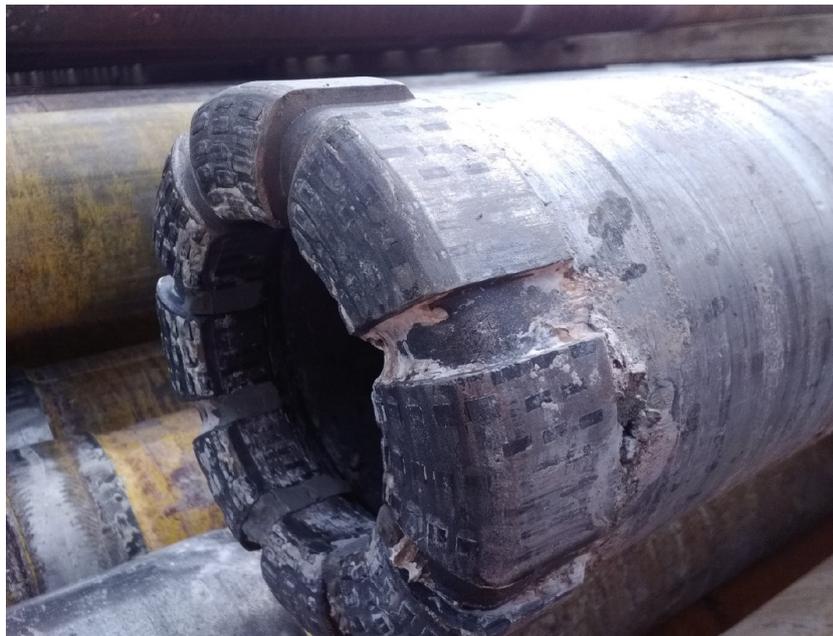
After performing a magnet run without any significant metal recovery, coring of Section III started using a synset core bit (see BHA #22 in Appendix N). Core length was fixed to 3 m as in the previous section. The synset bit cored until 796 m MD with constantly dropping ROP and was fully worn out after these 44 m (see Fig. 3-8).

Fig. 3-8: Synset core bit after POOH from the depth of 796 m MD

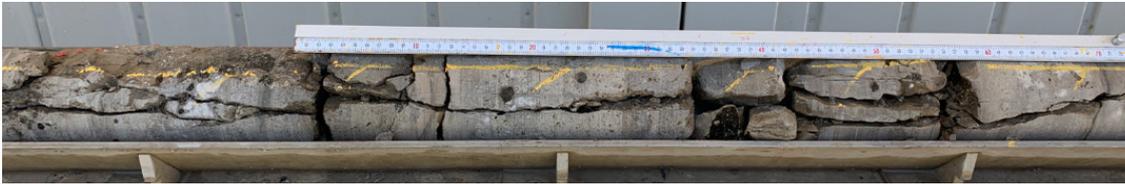
320 L/min to 650 L/min, adding up to 55 m³ in total. While pumping fresh mud, the mud weight was decreased from 1.29 SG to 1.25 SG. Fig. 3-9 shows the vertical fracture hit by the borehole trajectory which led to the encountered losses.

Fig. 3-9: Core picture of the vertical fracture in first encountered loss zone

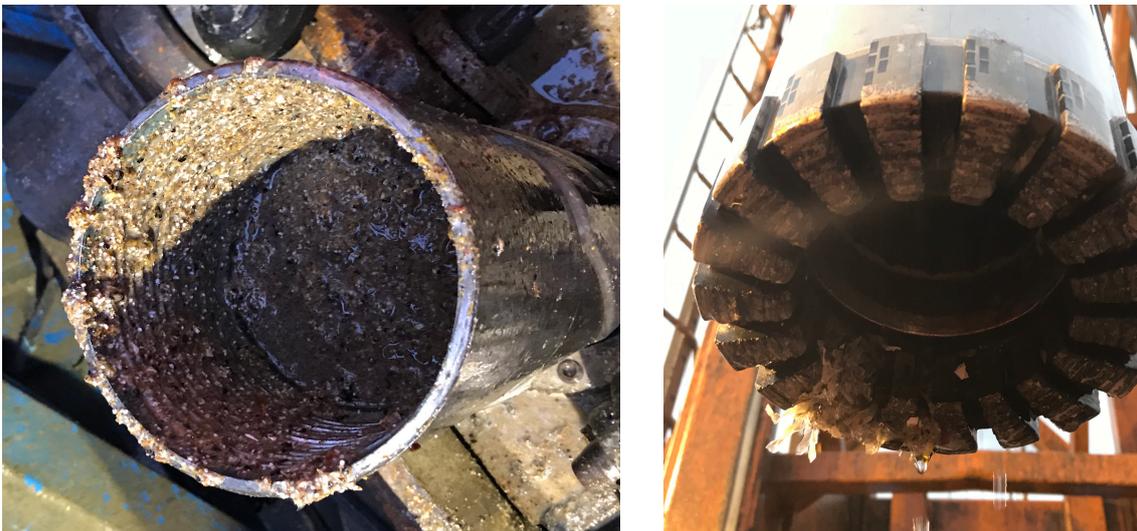
After the hydrotest, loss control operations using LCM started as soon as the coring string was back in the borehole. A total of 12 LCM pills had to be pumped before backflow and circulation were re-established. Nevertheless, completely sealing off the loss zone was not successful and the subsequent coring attempts failed. The surface and downhole equipment was contaminated and plugged with LCM (see Fig. 3-10) and had to be cleaned several times. The coring string also had to be pulled twice because the inner core barrel was not able to land on the outer core barrel and only small rock fragments were recovered after each coring attempt. There was no progress in coring because rock fragments became jammed within the inner core barrel. It was not possible to establish proper circulation due to an increase in the pumping pressure. The core bit was fully destroyed and completely lost its matrix (see Fig. 3-11).

Fig. 3-10: Equipment contaminated and plugged with LCM material

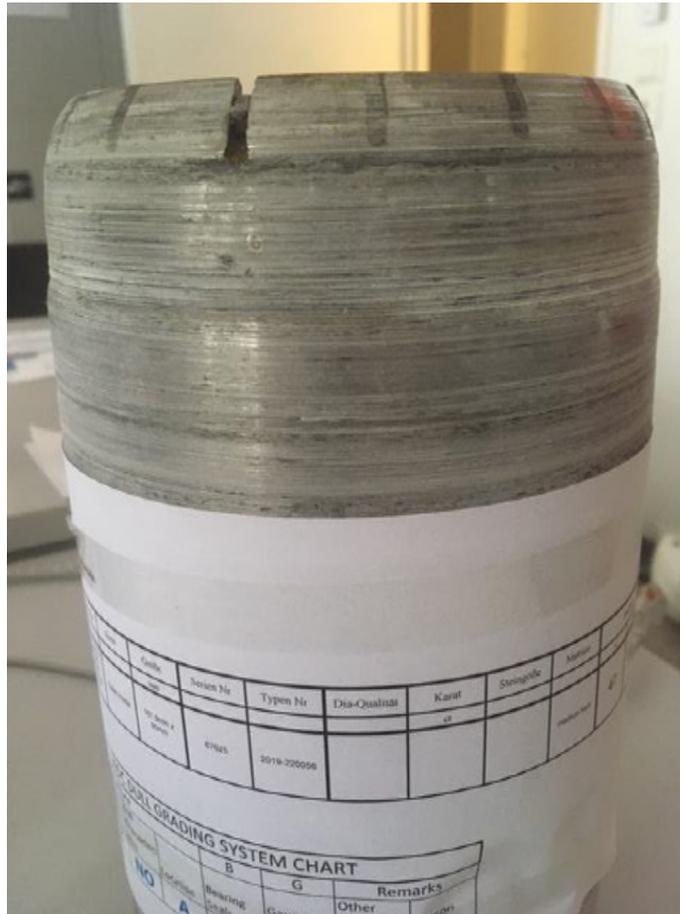
Fig. 3-11: Impregnated core bit fully destroyed without any matrix

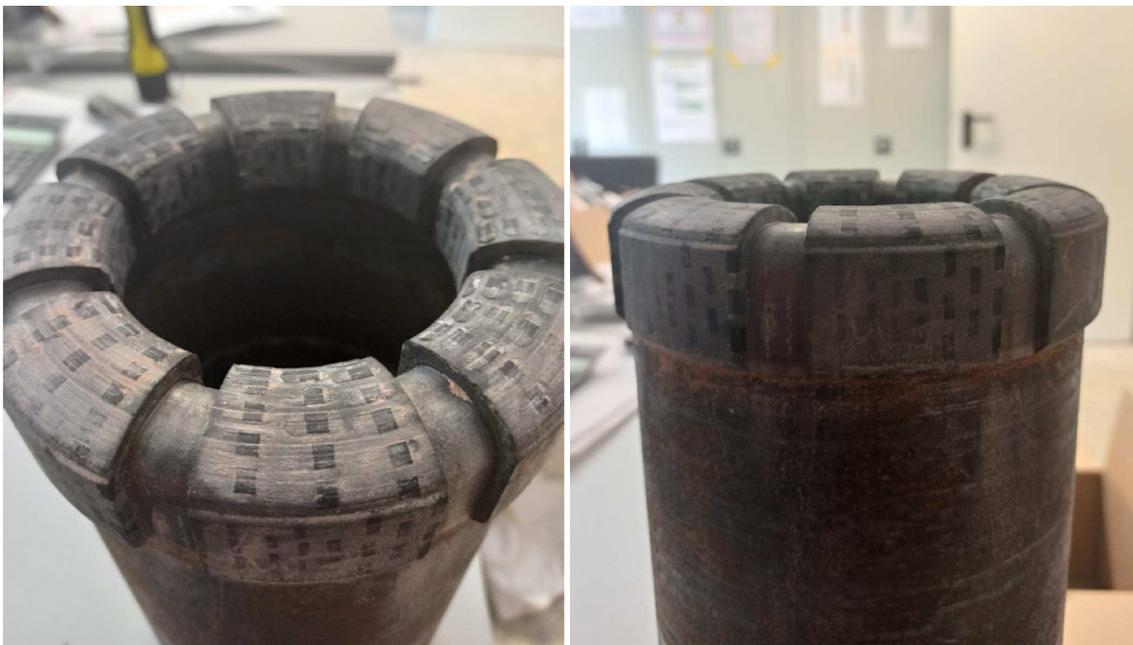
The mud exchange was conducted without any problems and coring operations resumed under dynamic losses of 60 L/min to 100 L/min until 1'054 m MD with fewer problems than before. Although the chloride content rose before the mud exchange, no salt layer was found in the Zeglingen Formation. The synset core bit was fully worn out after pulling out of hole (see Fig. 3-12).

Fig. 3-12: Synset core bit after pulling out of hole at a depth of 1'054 m MD

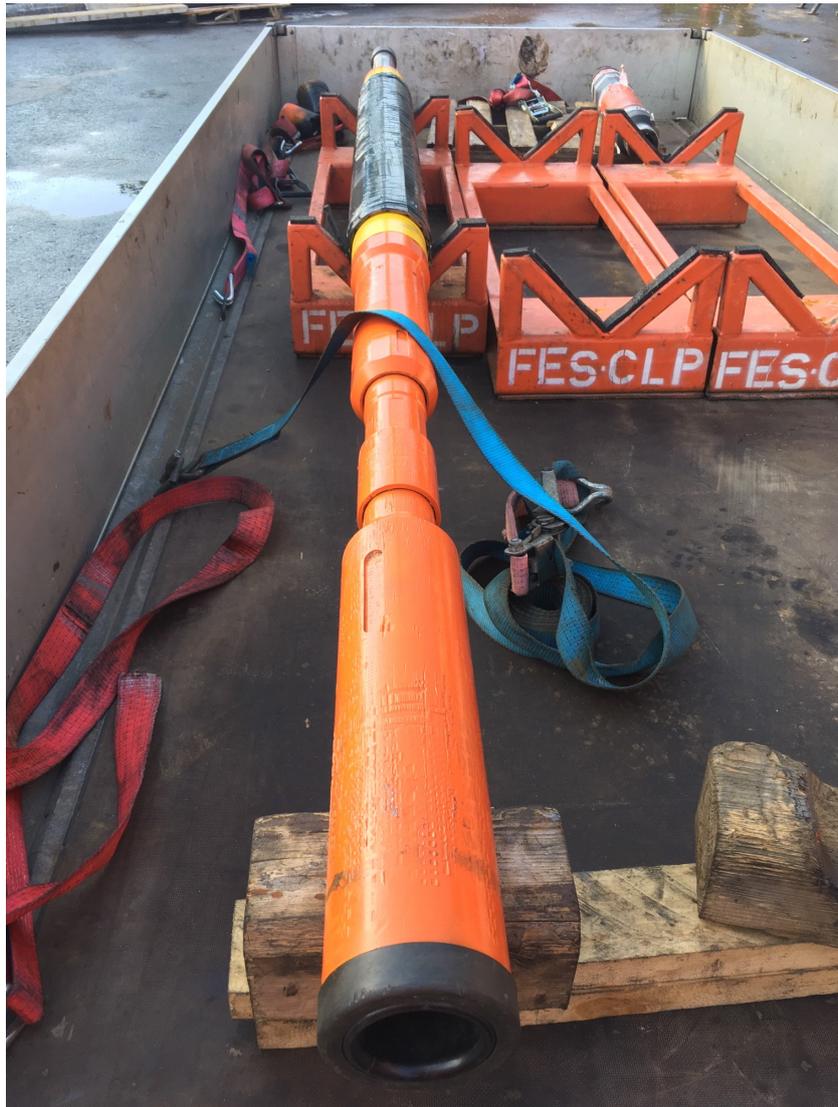
The next step was to set a 5½" open hole bridge plug (with turn release) at approximately 900 m MD (competent formation) above the lower loss zone and a second 5½" open hole bridge plug (with straight pull release, see Fig. 3-13) above the upper loss zone at approximately 865 m MD, also at a competent formation. It was planned to pull the upper bridge plug at a later stage to leave the Schinznach Formation open for potential long-term monitoring. After setting the two bridge plugs, the mud losses stopped immediately.

Fig. 3-13: 5½" open hole bridge plug with straight pull release

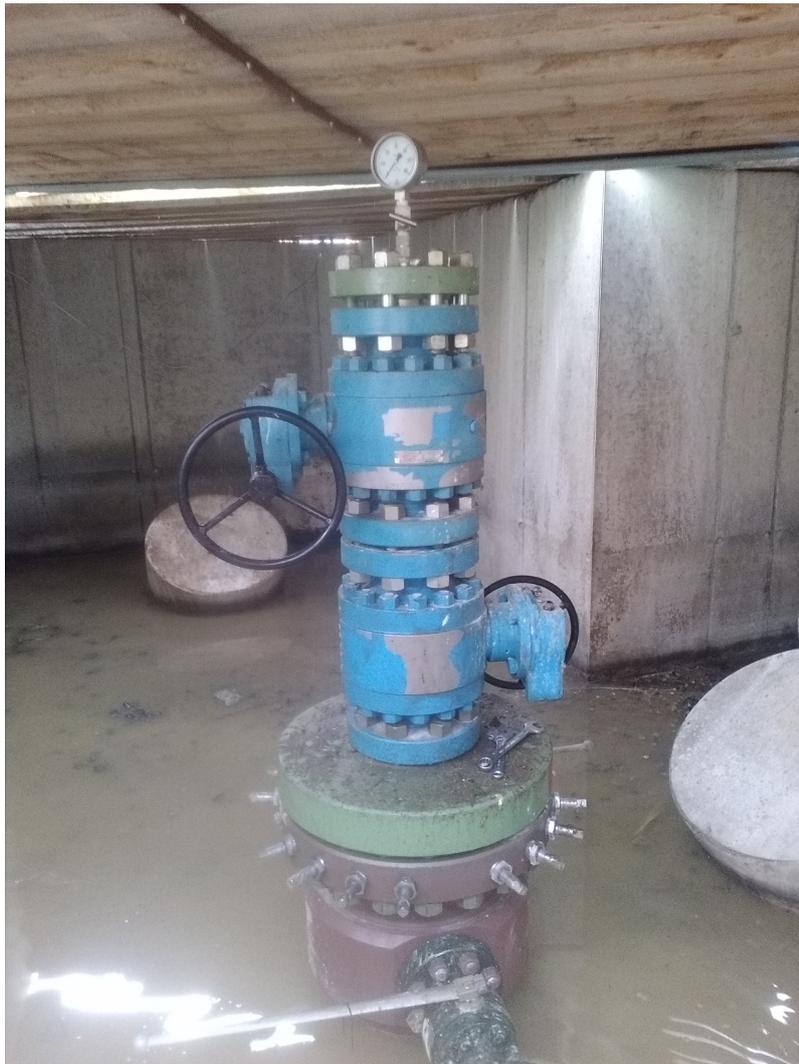
To finalise drilling operations in the MAR1-1 borehole, the saturated salt mud was displaced to a completion fluid (for pH regulation and corrosion protection) with MW 1.00 SG. Afterwards, the BOP stack was demounted and the wellhead (see Fig. 3-14) installed on the 13⁵/₈" CHH (brown colour). This wellhead was equipped with two 4¹/₁₆" ball valves (blue colour), installed on a 3K double studded adapter flange (green colour) which serves as a crossover from 13⁵/₈" to 4¹/₁₆".

Fig. 3-14: Wellhead installed after finishing drilling operations

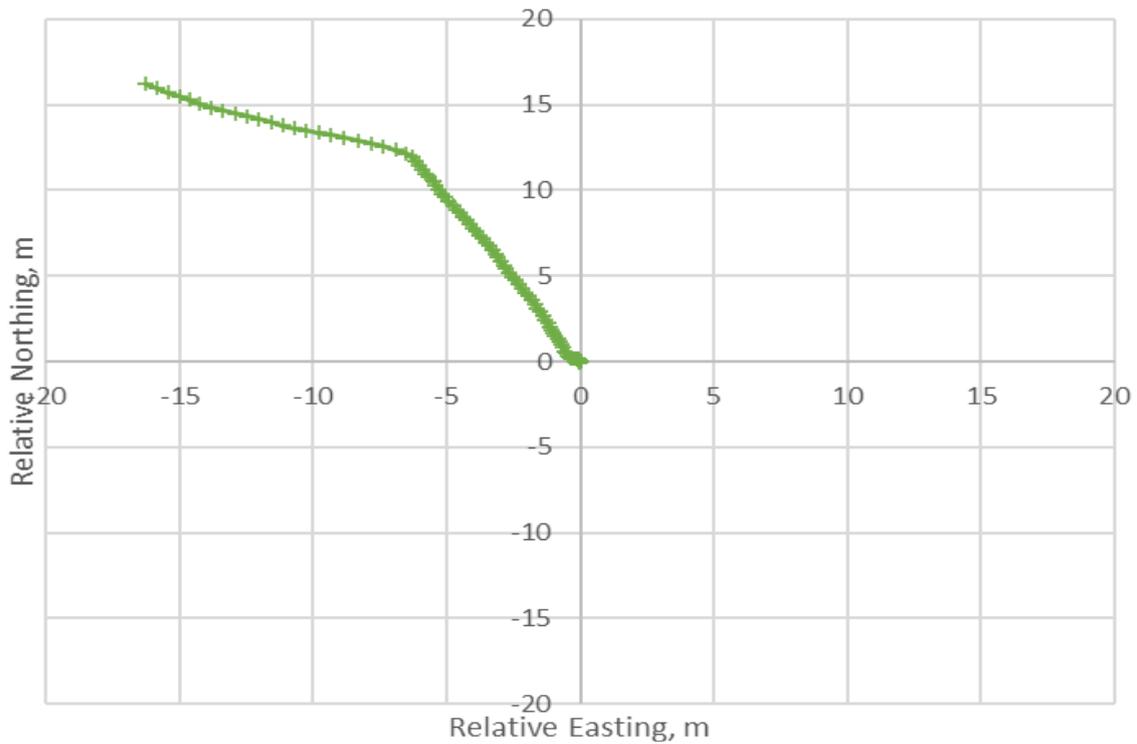
The inclination and azimuth of the MAR1-1 borehole were measured by performing two survey runs. The survey data filtered at 10 m intervals were spliced from the Polymetra gyro survey (0 m to 307 m TVD [true vertical depth]) through the casing in Section I, and Schlumberger wireline logging (> 307 m TVD). Figs. 3-15 and 3-16 show the borehole survey. Maximum dog-leg severity is 3.09°/30 m at 877 m TVD. Step-out at TD is 16.2 m north and 16.3 m west. The borehole can be considered vertical, and MD values mostly correspond to TVD values.

Fig. 3-15: Plan view: relative easting – relative northing

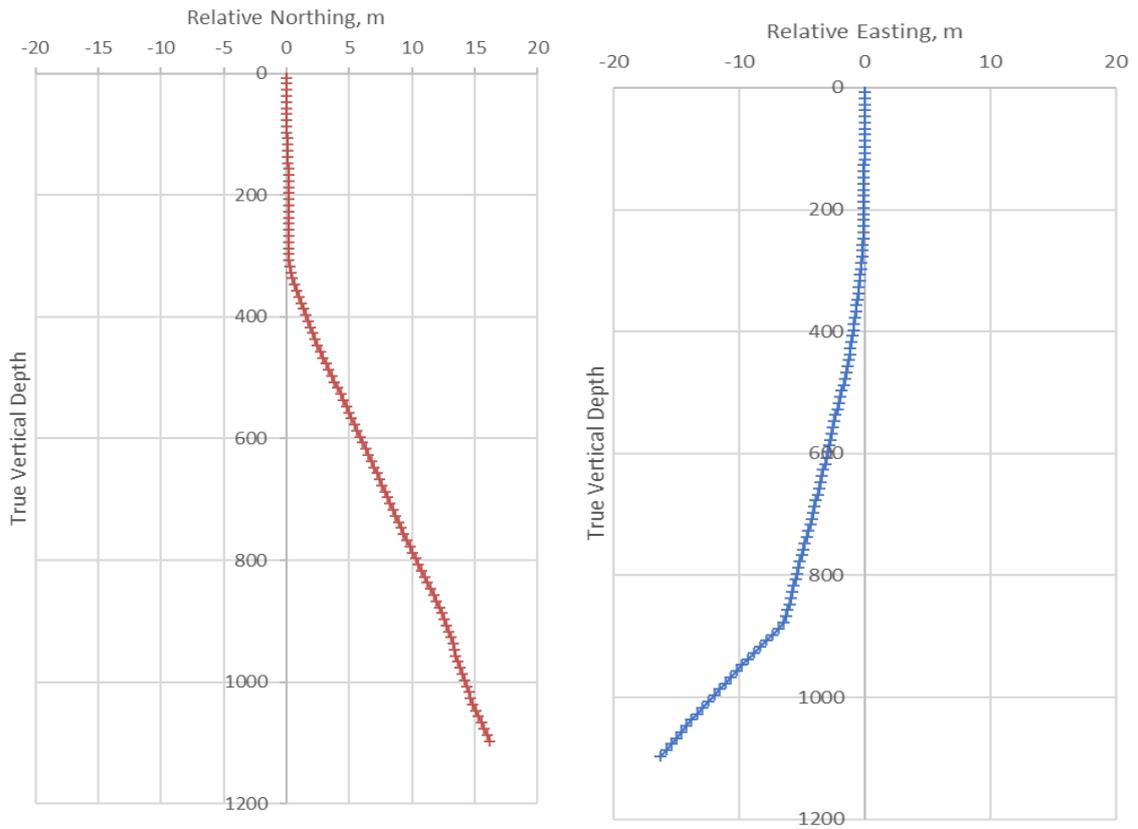
Changes in deviation occurred in the splice intervals between logging runs, including the 13³/₈" casing shoe of Section I at 308 m MD and the severely washed-out interval in the Schinznach Formation where total mud losses were encountered while coring at approximately 870 m to 877 m MD. No such change in deviation is seen at the 9⁵/₈" casing shoe of Section II at 748 m MD. Whether the increase in deviation is a result of changing the BHA, the casing installation, other operational practices or geological effects, or a result of FMI sonde deviation or sensor accuracy affecting measurements variably between logging runs is difficult to determine.

Fig. 3-16: Profile view: relative northing and relative easting – relative elevation (TVD)
