Arbeitsbericht NAB 22-03

**TBO Rheinau-1-1:
Data Report
Dossier II
Core Photography**

June 2023

**National Cooperative
for the Disposal of
Radioactive Waste**

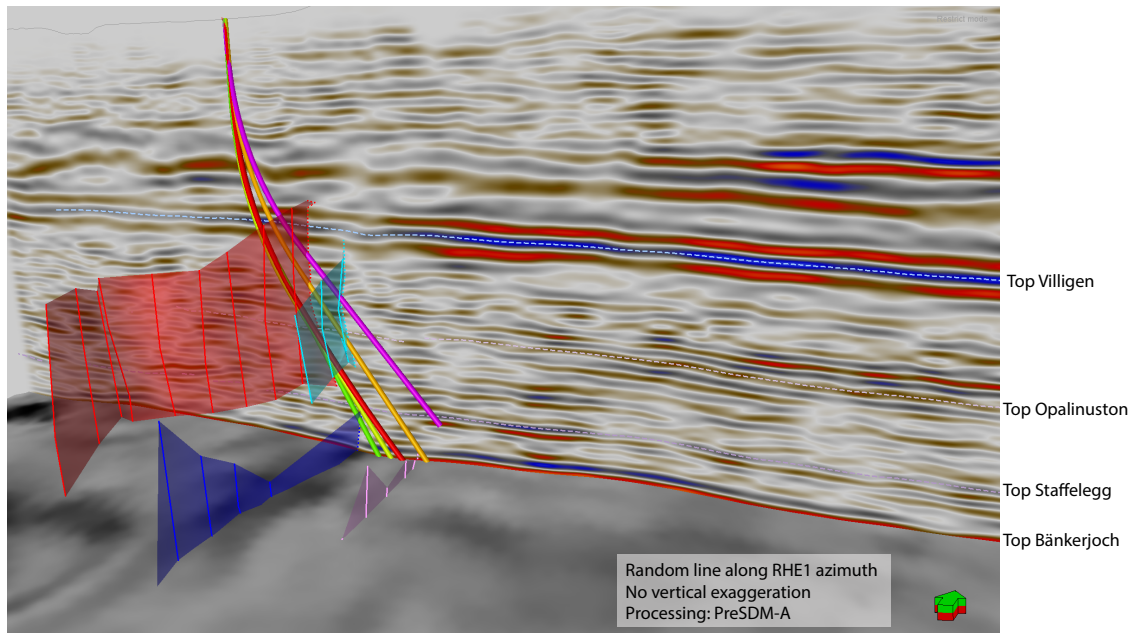
Fig. 1-4: Detailed seismic fault interpretation available for trajectory planning and discussed/executed well trajectories

Cross-section shows seismic amplitude (seismic processing: pre-stack depth migration PDSM-A). The north direction is indicated by a green-and-red arrow. The vertical distance between the Top Opalinus Clay and Top Staffelegg is ~120 m and shows no vertical exaggeration. The horizon slice shows polar dip attribute. Semitransparent subvertical surfaces indicate interpreted faults. The final planned and the drilled trajectories are shown in light green and red, respectively. Other discussed trajectories are shown in yellow, orange and red.

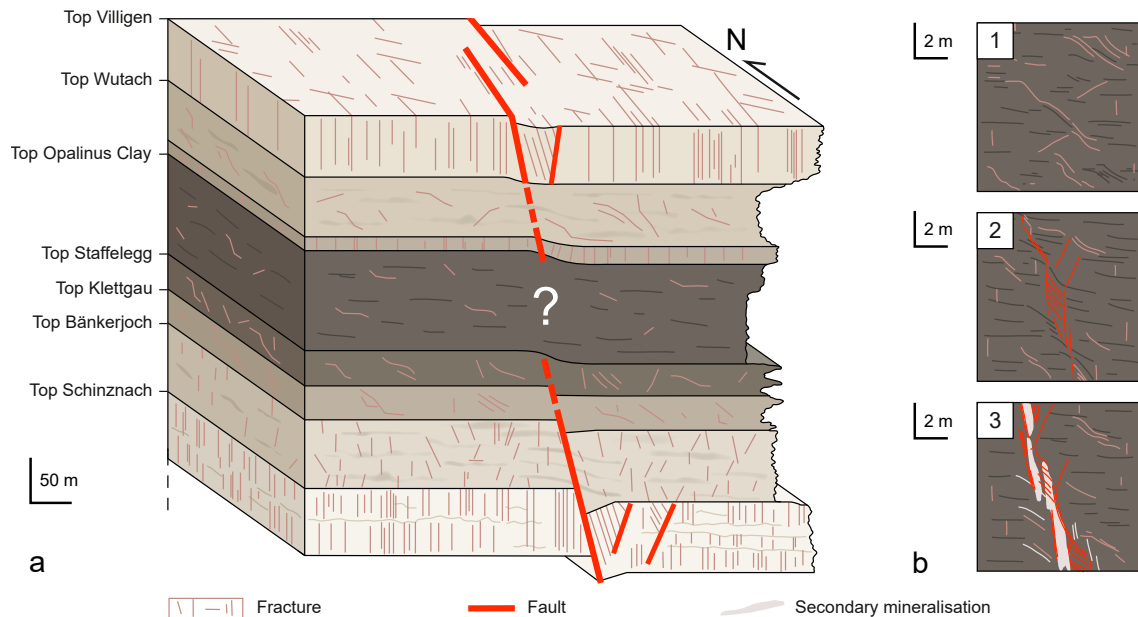
Fig. 1-5: Conceptual structural model of the Rheinau Fault

(a) Conceptual block model. The pronounced mechanical stratigraphy of the Mesozoic sequence in the area is stressed via a schematic weathering profile. The RHE1-1 borehole aimed at characterising the deformation style in the Opalinus Clay constituting a mechanically weak layer in between rheologically stiffer units (e.g. under- and overlying Schinznach/Bänkerjoch and Villigen/Wutach Formations). According to outcrop records and previous borehole results, these units show a significantly higher frequency of fault planes compared to the Opalinus Clay. In 3D seismics, the Rheinau Fault is also only clearly recognisable at the horizons related to stiffer formations.

(b) Hypothetic deformation characteristics of the Opalinus Clay to be encountered in the RHE1 1 borehole: 1) No exceptional deformation features besides small-scale fault planes as previously observed in vertical boreholes outside of seismically recognised faults. 2) One or several localised zones associated with cataclastic fault rock (e.g. scaly clay) as described for larger fault zones elsewhere (e.g. Jäggi et al. 2017). 3) The above, but also including secondary mineralisation (not to scale on picture).

Fig. 1-5 shows a conceptual structural model for the Rheinau Fault incorporating both 3D-seismic interpretations and observations from other exploration boreholes as well as from outcrop studies. This conceptual model shows a pronounced mechanical stratigraphy of Northern Switzerland's Mesozoic sedimentary sequence with more focused deformation in the competent units, and distributed deformation in the incompetent units (Roche et al. 2020). Prior to drilling, three hypotheses were formulated on what the RHE1-1 borehole is likely to encounter in the Opalinus Clay. These hypotheses ranged from 1) absence of a distinct fault zone, likely due to a strong degree of strain partitioning within the rheologically weak Opalinus Clay, 2) one or several prominent fault zones, for example revealing cataclastic fault rock or scaly clay as it has been described to occur along larger faults within the Opalinus Clay (Jäggi et al. 2017) and 3) the former, but including the occurrence of secondary mineralisations.

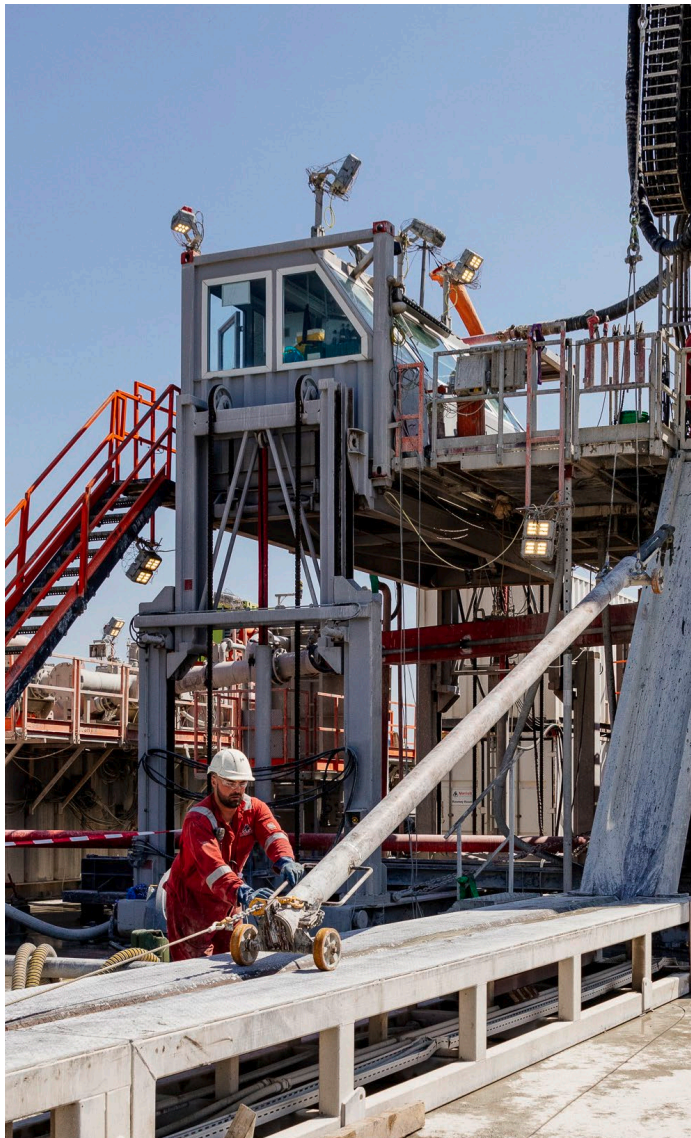
Fig. 2-1: The inner core barrel is placed on the pipe rack

Showcase picture of rig 16 (Marriott); workflow comparable at the Daldrup rig
(picture credits: © Maya & Daniele)

The cores were drilled with a 6 m long inner core barrel containing an inner plastic tube. To avoid core jamming and to obtain a better core quality the length of a core run was 3 m, only. After cutting the core, the drilling crew pulled the inner core barrel up with a winch (wireline coring) and placed it on the pipe rack (Fig. 2-1). The core catcher was detached and the inner plastic tube was removed and laid down on trestles. The section containing the core was separated from the empty plastic tube by cutting the tube to a length of approximately 3.5 m. The core was then carried to the core processing area (Fig. 2-2) and pushed out of the tube using an appropriate rod. If the core was jammed inside the tube, the plastic liner was cut laterally using an electric cutting machine.
